# **Muon Radiography with the Plastic Scintillation Counter**

**(The imaging of the large Structure)**

KEK, Univ. Tsukuba, Tokyo Met. Univ.,  
Univ. of Tokyo, TEPCO

**2016 - 3 - 2**

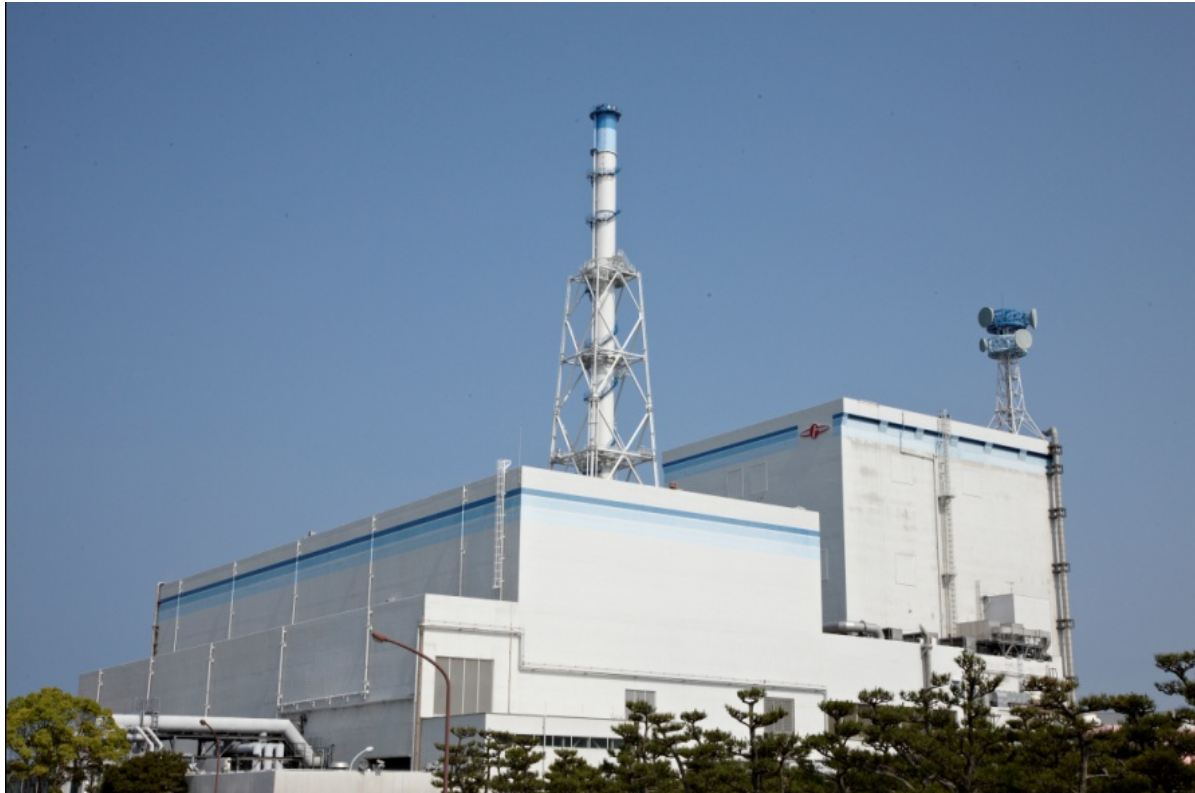
## **2: Test Experiment at the JAPC @Tokai, Ibaraki**

Nuclear Reactor was studied at three locations.

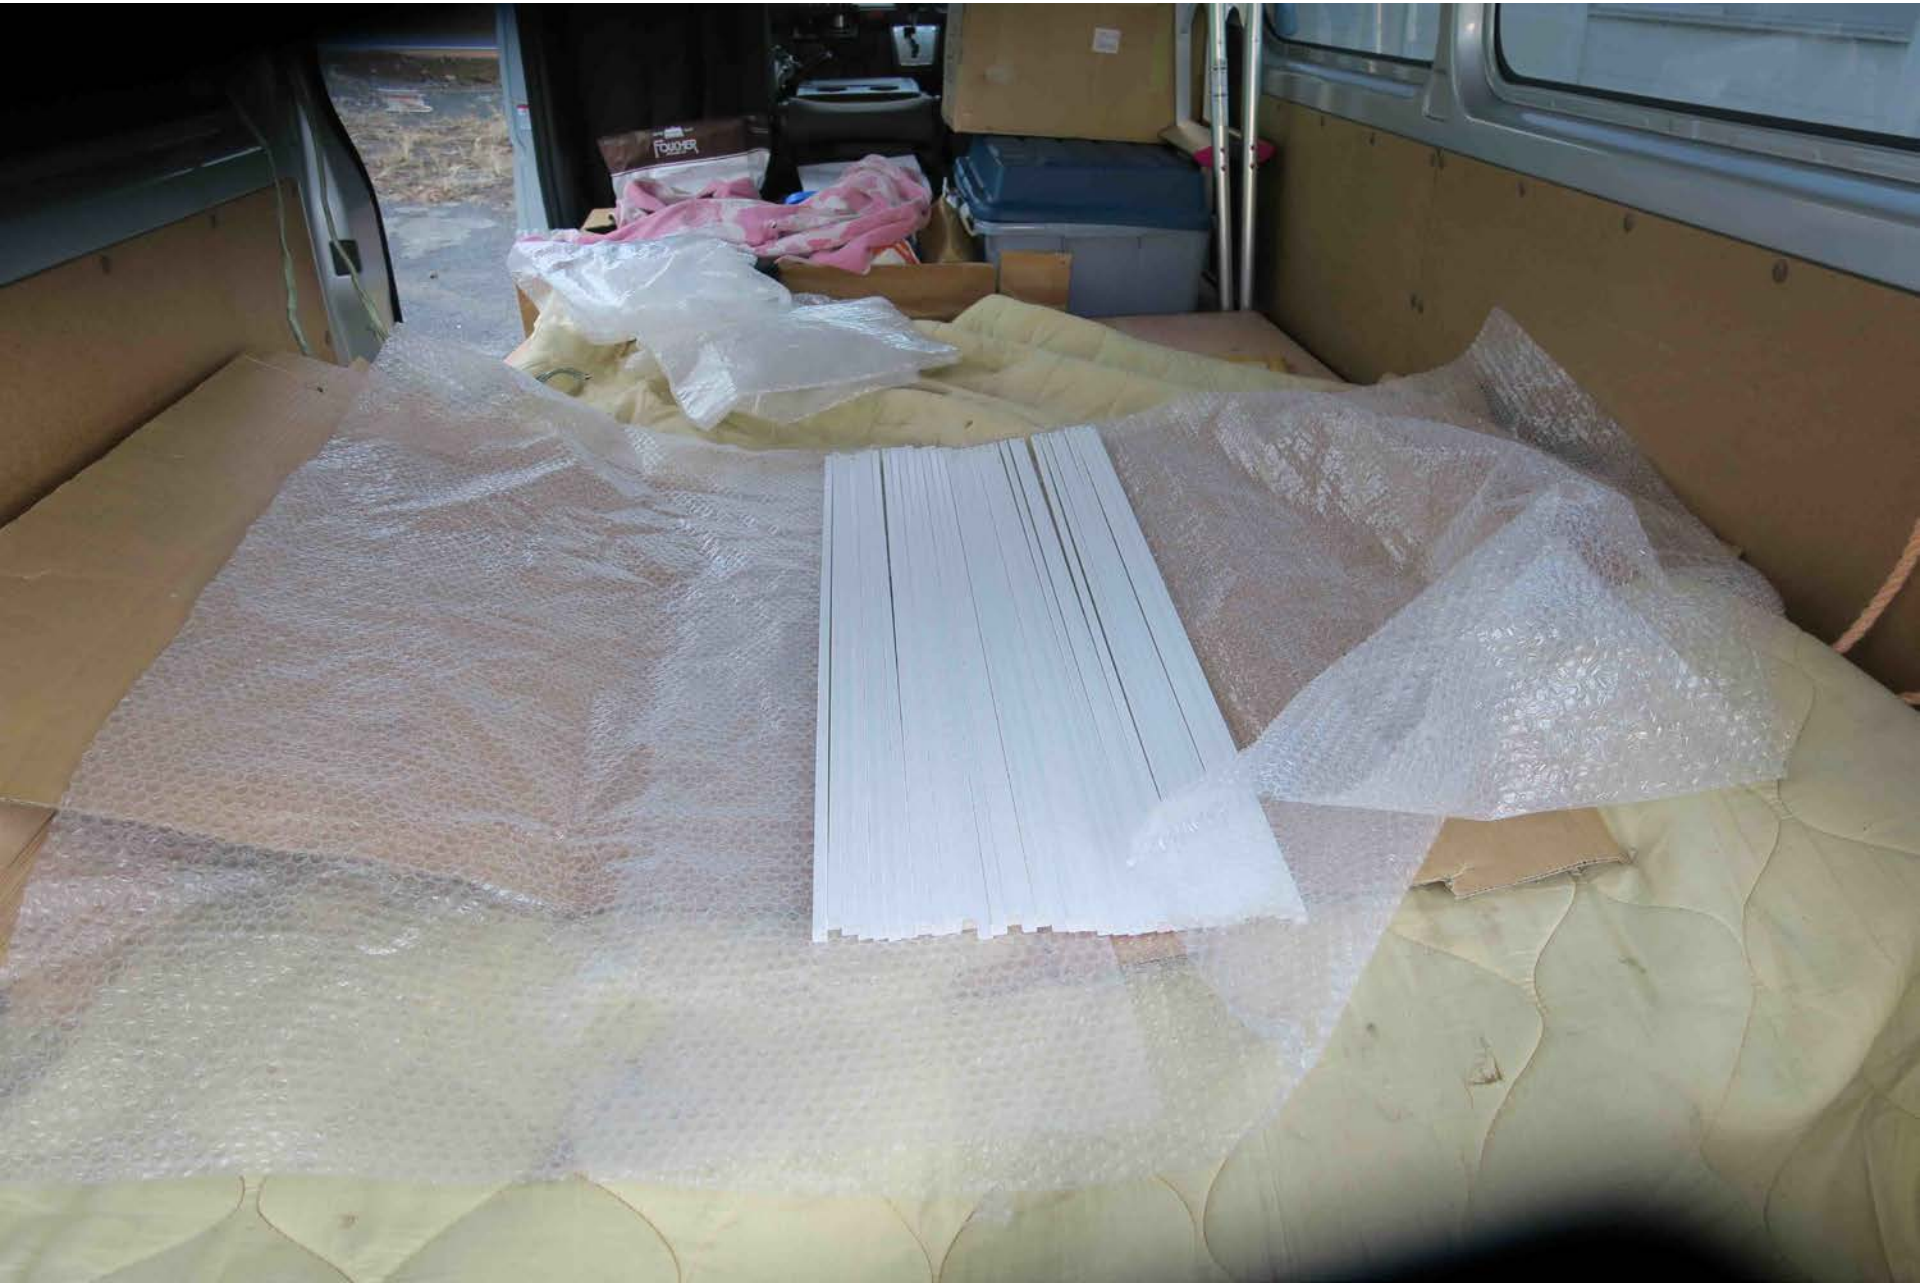
# Cosmic Muon Detector

## Plastic Scintillator Bar + Wave length Shifter Bar

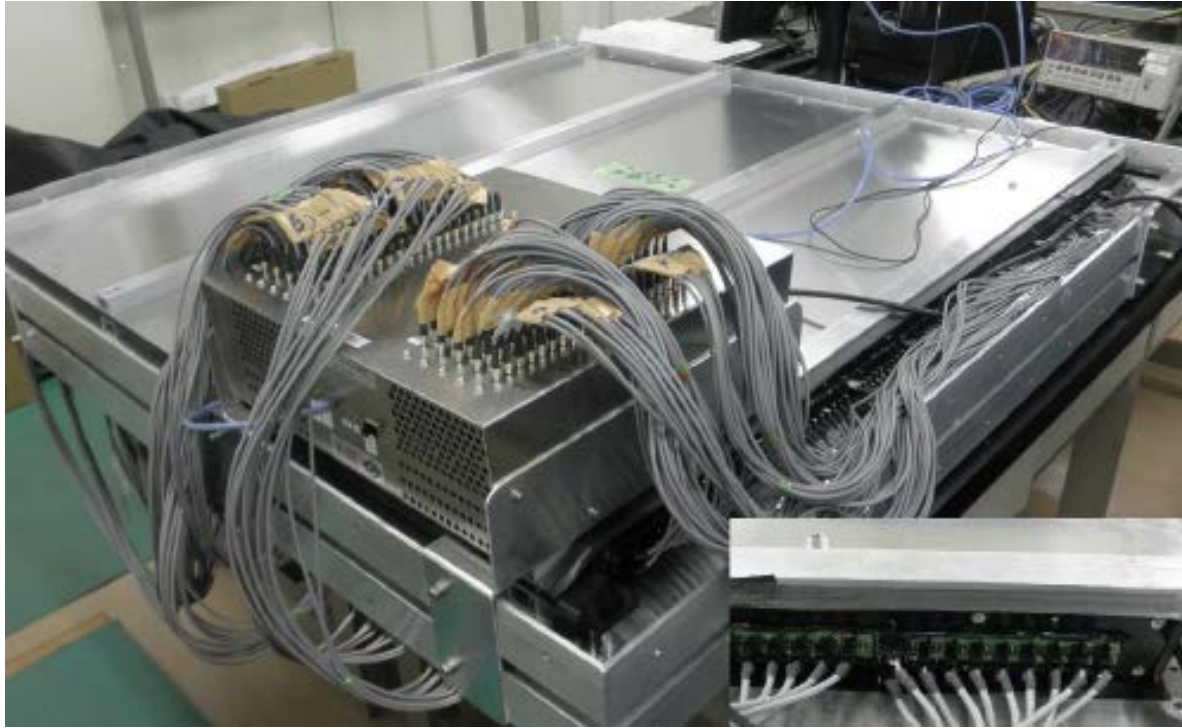
# X-Y Detector Unit

アルミ枠(厚さ1cm)

端部を折り曲げ加工し、強度を強める。

Front End Board

110cm角

シンチレータ前後面に反射シート(白色PET)  
さらに外側から遮光用黒シート

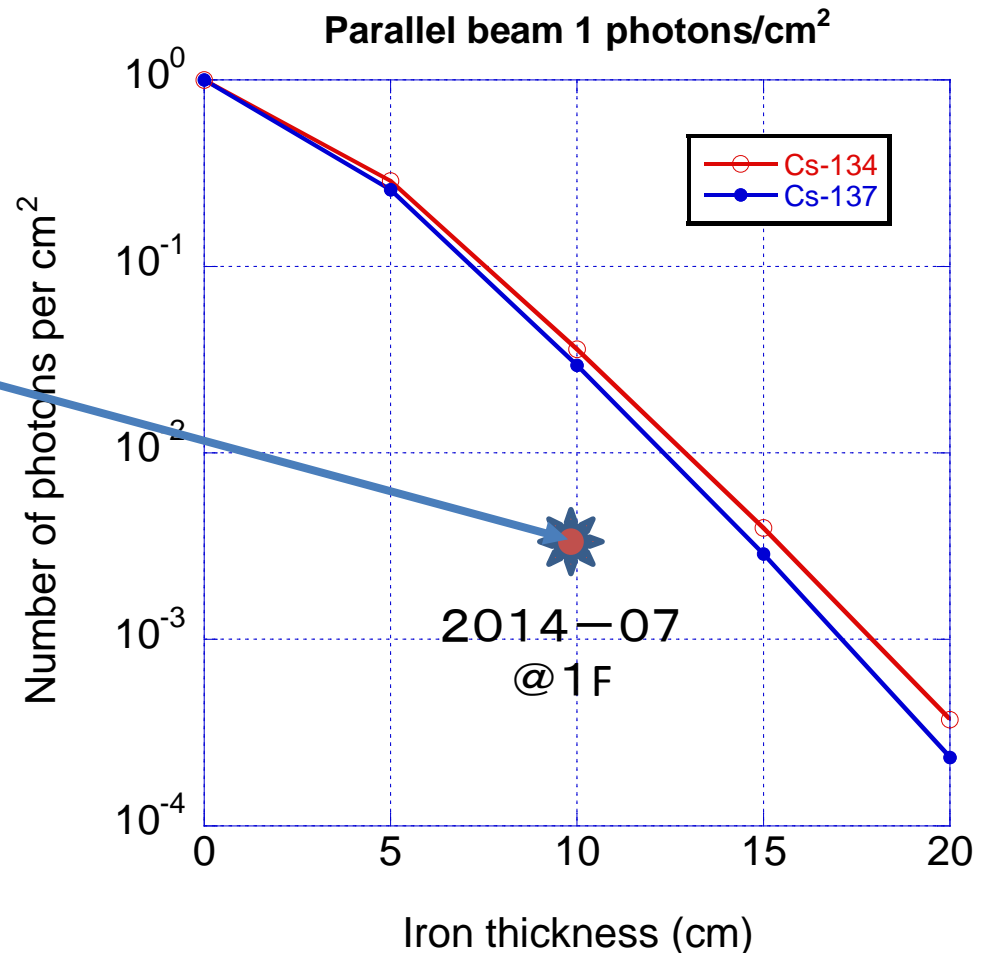
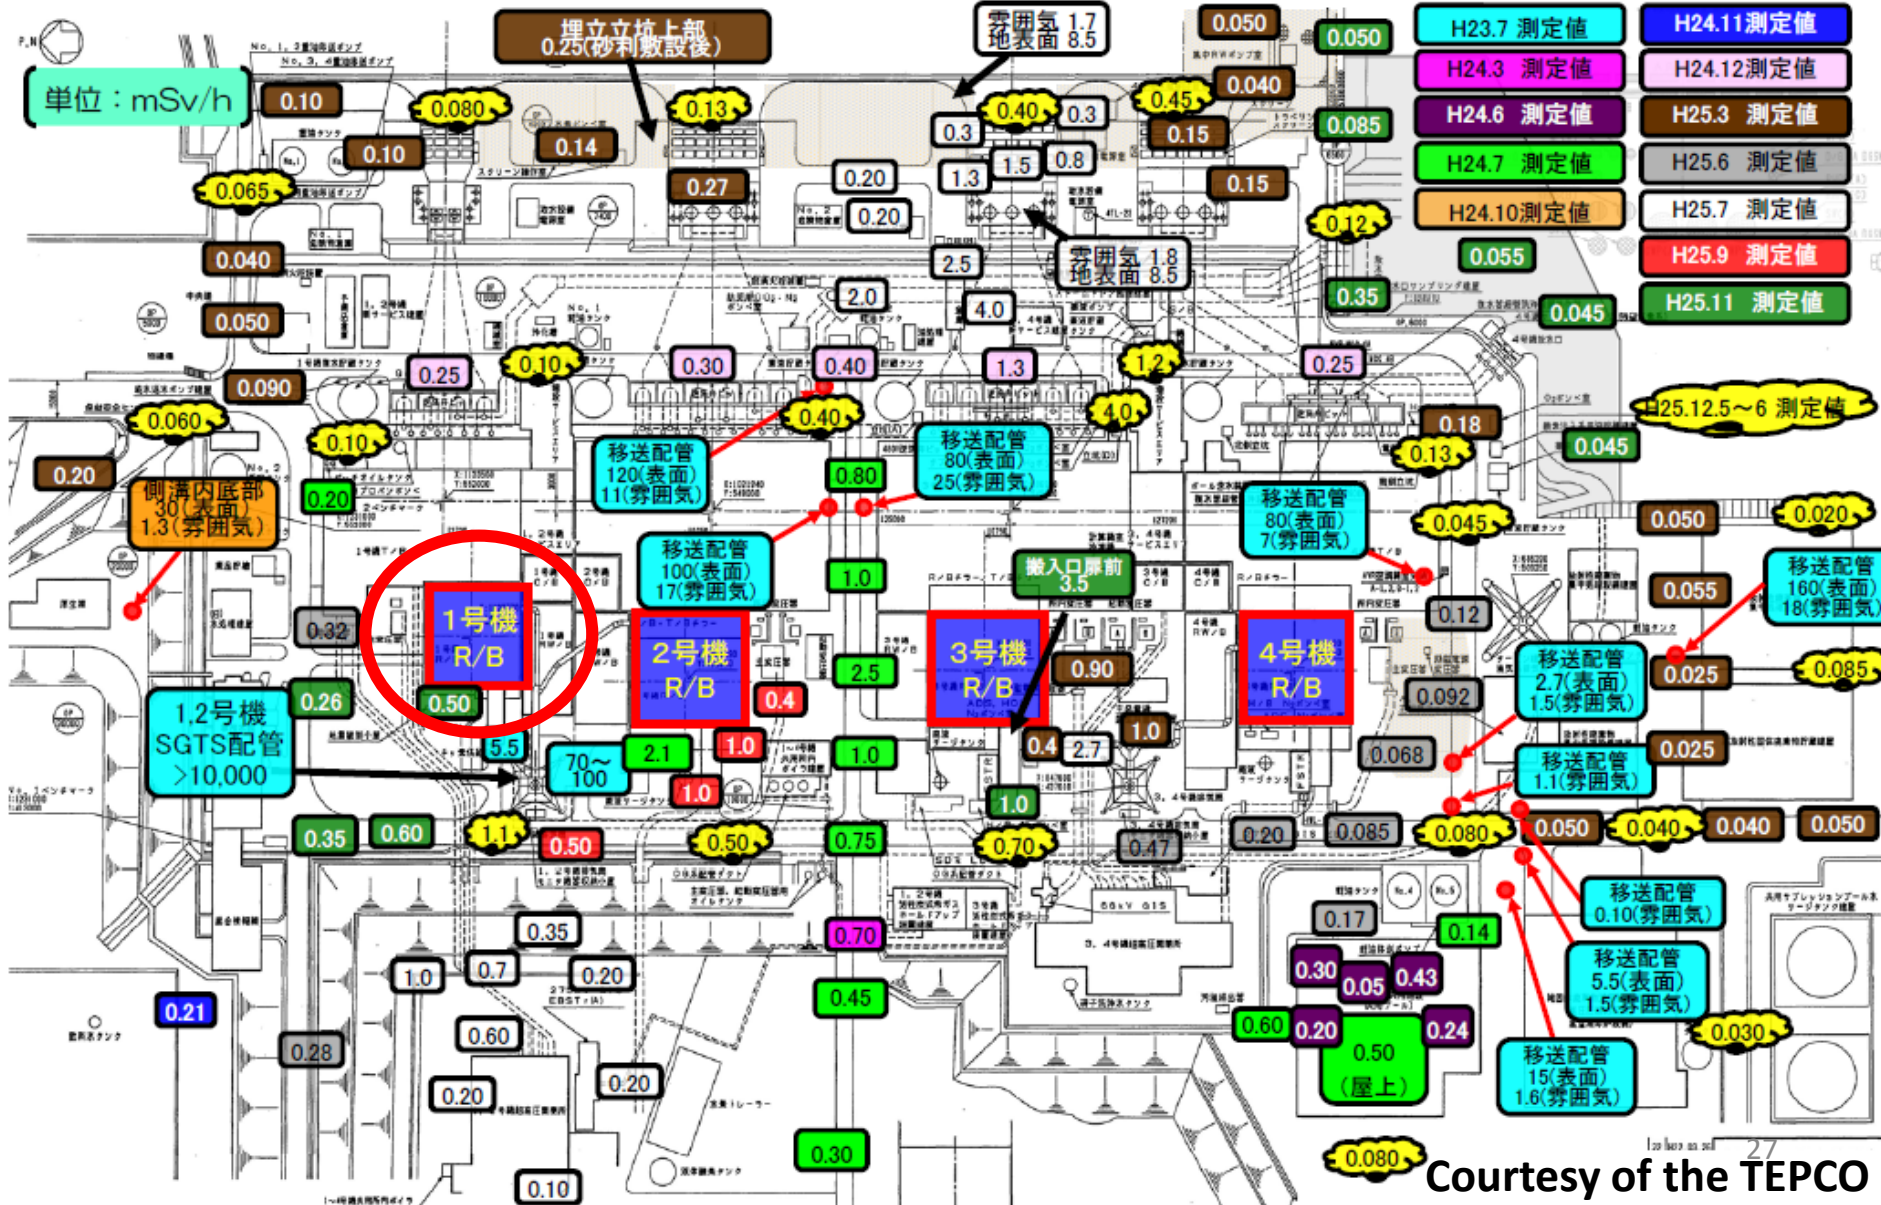
Measurement at Fukushima

# 3-2 : Protection of the Detector against the environmental radiation of $O(0.5\text{mSV} <)$

## 福島第一サーベイマップ (平成25年12月6日 17:00現在)

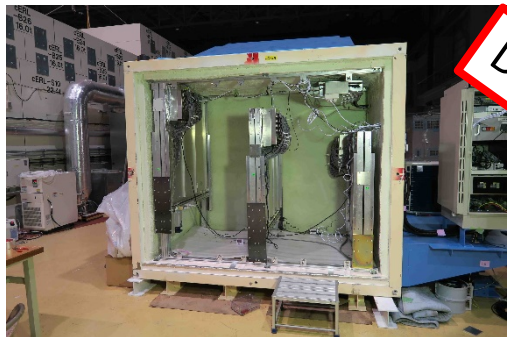
# Rough image of Unit1 R/B and T/B ~1st floor plan~

**Data : Sent to the other building**

~20.8m

Assigned Detector Locations

Building Cover

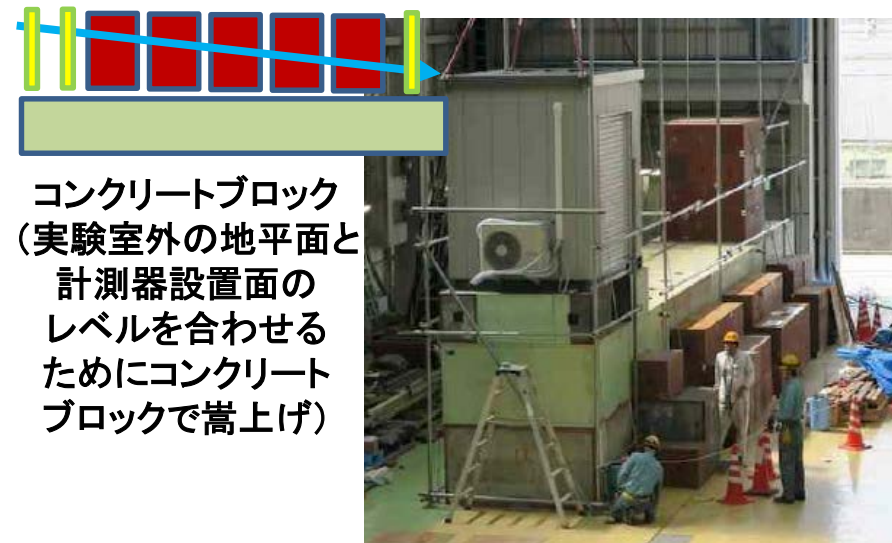
## 鉄ブロック

鉄ブロック (通過する鉄の量からミュオンのエネルギーを測定)
